Kinder Morgan Linnton Terminal River Bank Erodability Assessment

PREPARED FOR: Kinder Morgan Liquids Terminals LLC
PREPARED BY: Todd Cotten/CH2M HILL
COPIES: Keith Sheets/CH2M HILL
Eric Aronson/CH2M HILL
Jeff Gentry/CH2M HILL
DATE: November 15, 2010

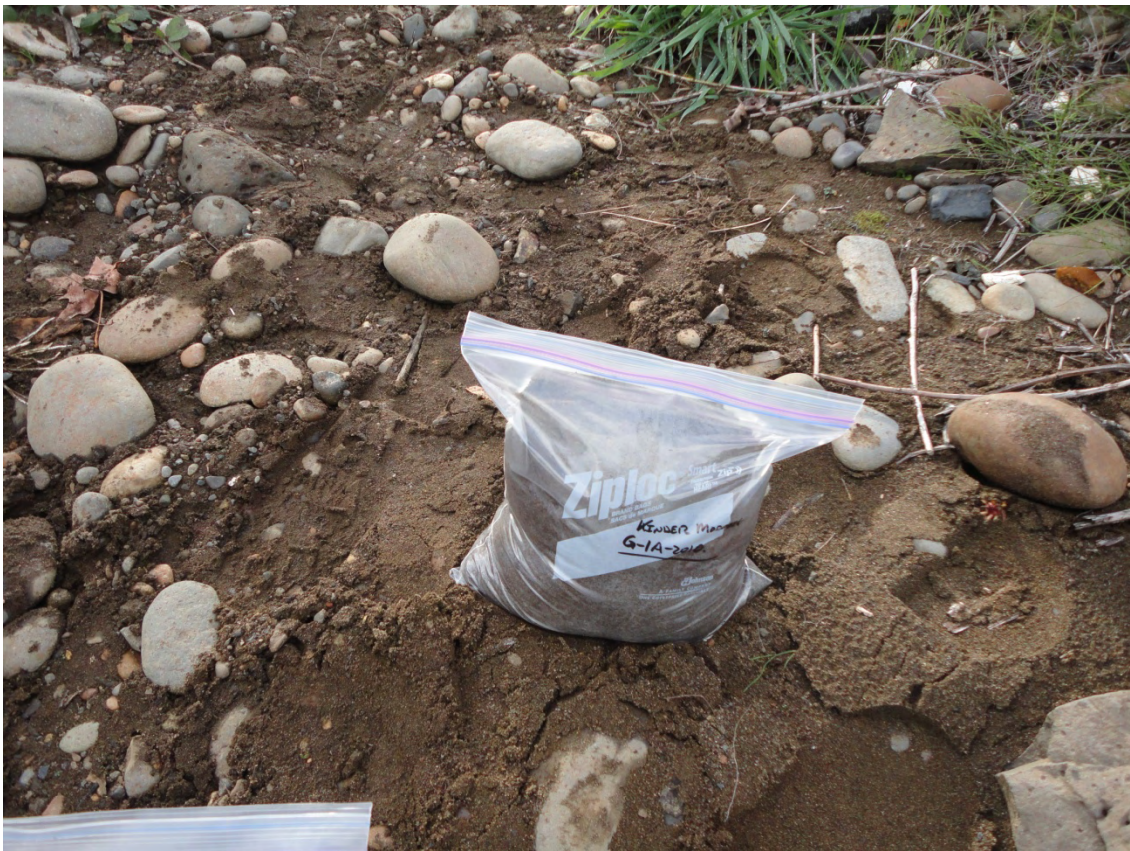
There is evidence of minor erosion of the bank in this area from surface water runoff. Surface water appears to collect at the top of the bank and flow down the bank near Station 10+00. The area where signs of surface water erosion were observed is shown in Figure 3.

A bulk sample of bank material was collected for grain-size analyses along the upper portion of the bank near Station 10+05 as shown in Figure 4B. The sample was labeled as G-1-2010.

Pictures of this section of the site are presented in Photographs 22 through 25 in Appendix A. Photograph 25 shows the conditions where sample G-1-2010 was collected.

Photograph 25: Station 10+05 Surface conditions at location of G-1-2010 sample.
